WHITMANS POND DAM

MA 00775

PHASE I INSPECTION REPORT
NATIONAL DAM INSPECTION PROGRAM

AUGUST 1980

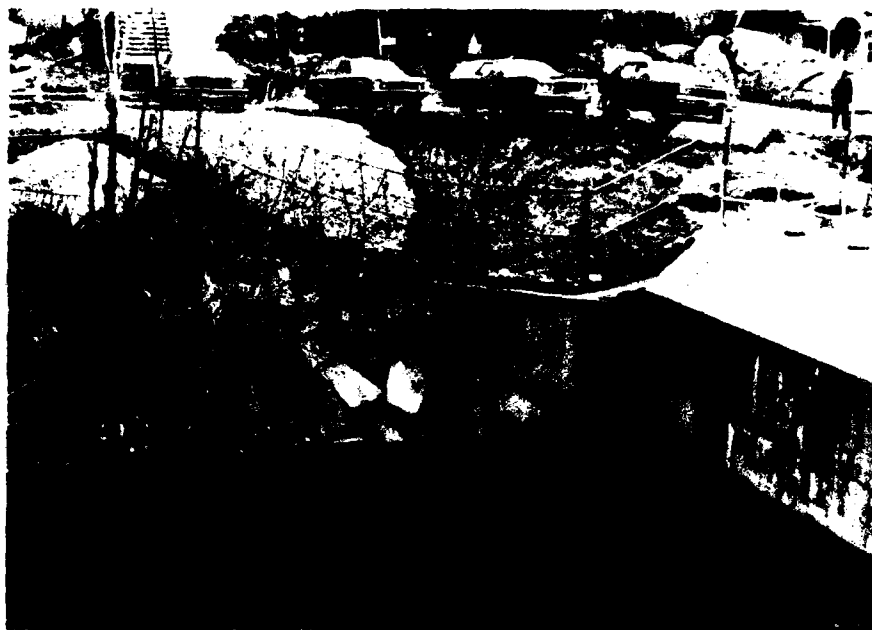
The downstream face of the dam as shown in Photo's #1,2,3 and 4 is in good condition. Heavy stone revetment downstream of the training wall to the right of the outlet end of the siphon structure has been displaced and there is minor erosion downstream of the right training wall (see Photo #5).

5. Displaced riprap and erosion downstream
of right training wall

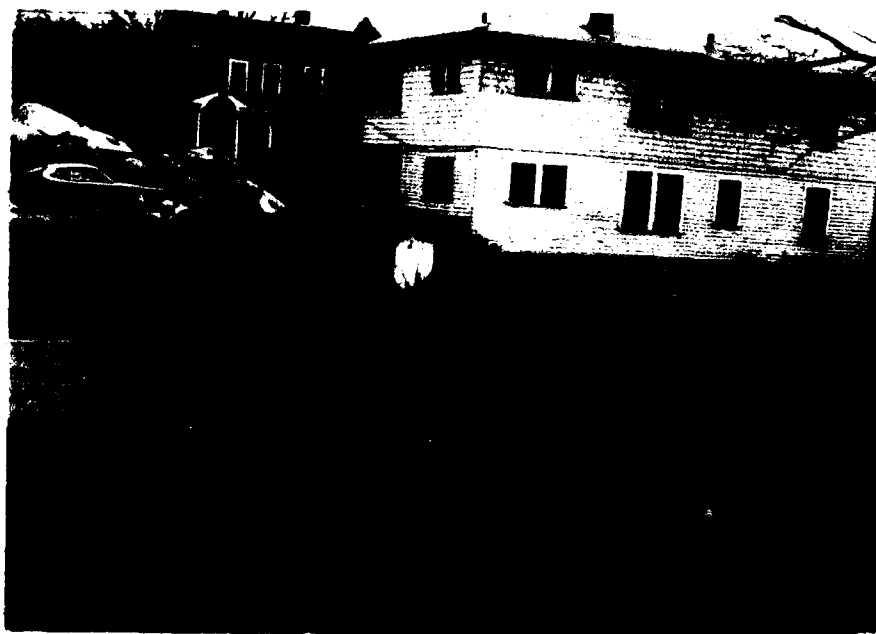
Photo #8 is a view of the right training wall of the approximately 350 ft. long spillway approach channel. This rubble masonry wall is part of the older dam which was replaced in 1935. The wall appears to be in good condition in spite of the fact that the joints are not mortared.

8. Right training wall of the spillway
approach channel
